FULL PUMP

**REFURBISHMENT BY
HAYLEY 247 DEXIS
IMPROVES ENERGY
EFFICIENCY**

CS01424/7

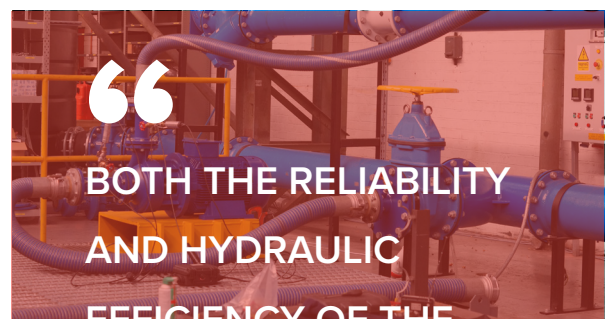
detailed condition report, with all issues found then addressed. The pump's impeller, volute casing, and back wear plate were also coated with Belzona 1341 to reduce friction losses and improve the pump's hydraulic efficiency.

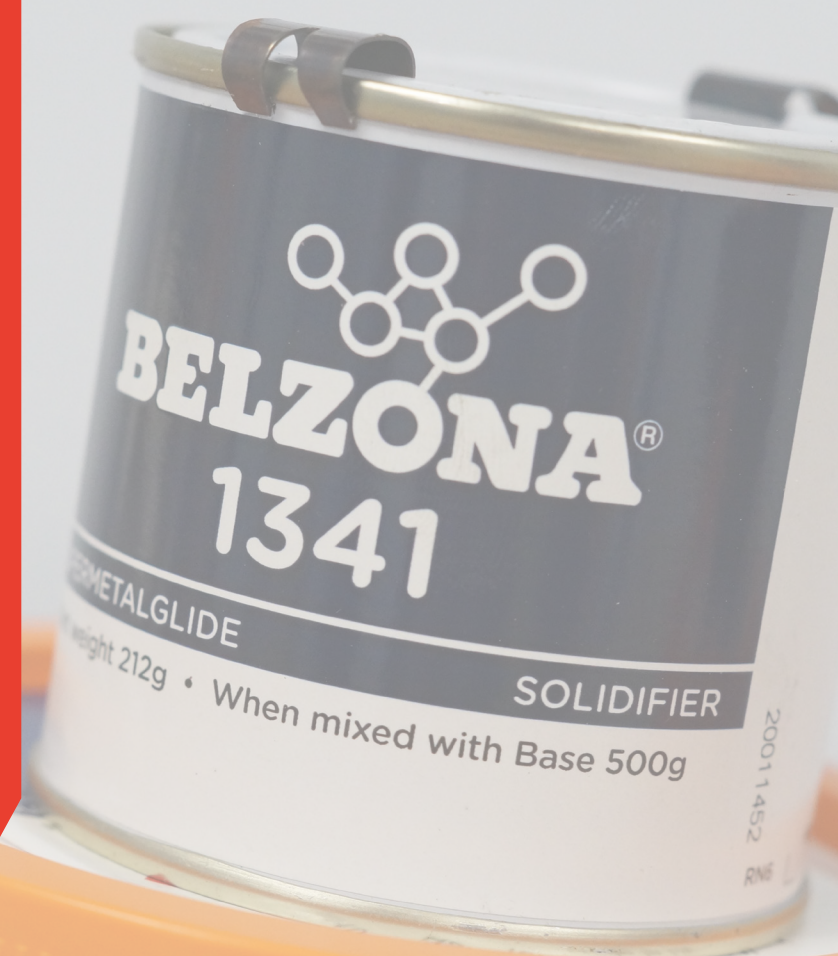
Following the standard strip and inspection being completed at the Dudley workshop, it was determined that the pump's internal clearances were outside of both the OEM's values and the Water Industry Mechanical & Electrical Specifications (WIMES). A full energy efficiency refurbishment was recommended and accepted by the customer.
