CASE **STUDY**

HAYLEY 247 DEXIS

**HELPS TO BRING
CHEMICALS PLANT
BACK ONLINE
WITH PUMP
REFURBISHMENTS**

CS102

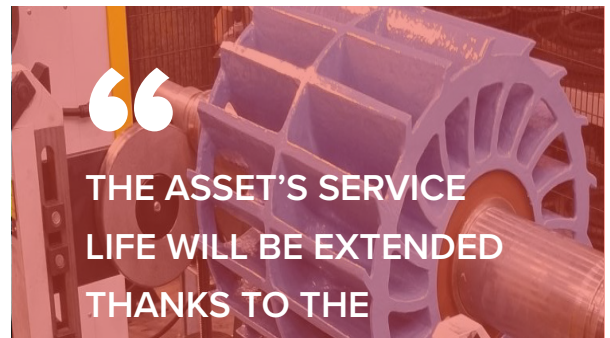
One of the pumps in question arrived at the HAYLEY 247 DEXIS facility in Dudley, where a standard strip and inspection of the pumps' individual components, was conducted. The main issue identified was the large amount of cavitation erosion present in the pump impeller. The pumps' end shields and port plates were found to have a large amount of metal debris, with debris also found within the mechanical seal housing. The NDE bearing was also overlubricated and worn beyond repair.

The customer was happy to accept the proposal which included; replacements for the worn bearings, rings and seals, with the impeller being rebuilt using Belzona 1111 and

coated with Belzona 1341 efficiency coating, a product renowned for its ability to both protect against further erosion and improve an assets' energy efficiency. The unit was also subjected to a dynamic balance and full testing procedure before being returned to the customers' site.

Now that the pump impeller has been coated with Belzona 1341, the assets' service life will be extended thanks to the Belzona 1341's anti-corrosion qualities, and its hydraulic efficiency improved, reducing energy consumption as a result.
