**5 SYMPTOMS**

**OF PREMATURE  
V-BELT FAILURE**

DP059

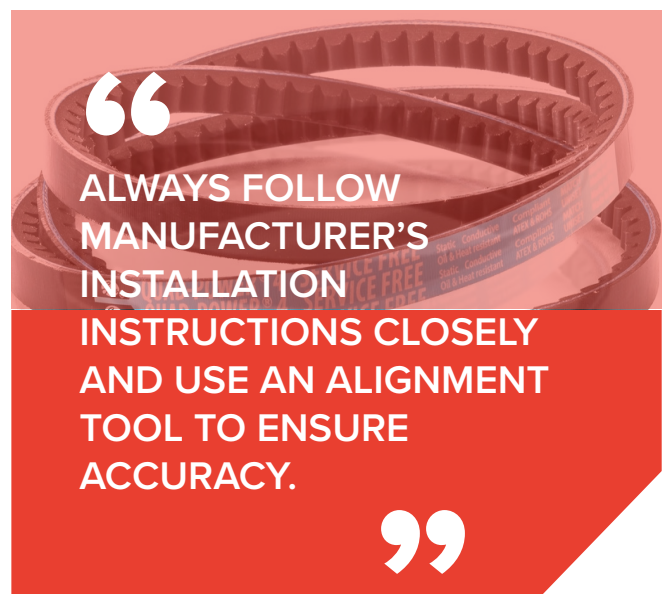
Splitting of v-belts or separations in the belt body and/or ribs is often a tension-relation issue that originates in installation. Forceful fitting of an unsuitable v-belt or running it with the incorrect tension is regularly to blame for splits and separations. The manufacturer's guidelines should always be followed when mounting and adjusting the tension of a belt to avoid running into future problems.

Separations in the belt body and ribs could also be caused by solid debris wearing one section of the belt more than others until it reaches the point where the rib peels from the belt's base. Immediately replace any belt displaying these deformities and ensure that the new v-belt is correctly positioned on the pulleys, as well as checking for foreign objects capable of damaging your belt and the components around it.
