HAYLEY DEXIS

**PROVIDES SOLUTION
TO LEAKING GEARBOX
AT WATER TREATMENT
SITE IN NORTH
SOMERSET**

CS006

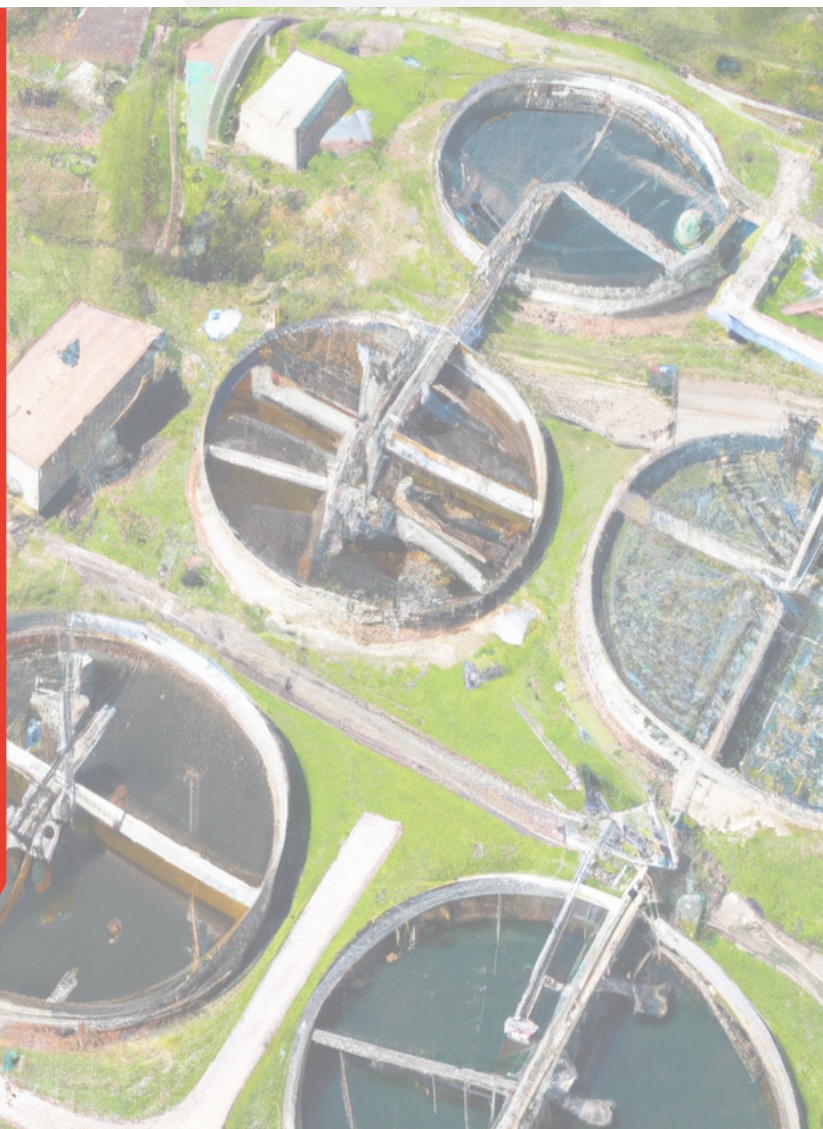
The operator of a major water treatment works in North Somerset was having major issues with failing gearboxes on their primary tanks. The gearboxes were all 40+ years old and spares were no longer available, with the manufacturer having gone out of business. The units were leaking from their output shaft seals, and risked leaking into the tank – something which would cause real problems for the customer.

The HAYLEY DEXIS team worked with the customer to source a modern solution capable of fitting in the confined space occupied by the current unit. A modern helical bevel unit was supplied, with a special fabricated output baseplate and shaft to match the original.

All modifications were conducted on-site at HAYLEY DEXIS, meaning very little shutdown time was required for the customer. The electric motor meets the latest IE3 specification – saving energy and lowering costs.

The bearings within the unit have been respecified and fitted to carry larger loads and be more resilient. The unit now also has a larger mechanical service factor where, if required, the motor can easily be changed for a larger unit to increase production.
