# CASE STUDY

#### **HAYLEY DEXIS**

## MECHANICAL ENGINEERING SERVICES // AUTOMOTIVE

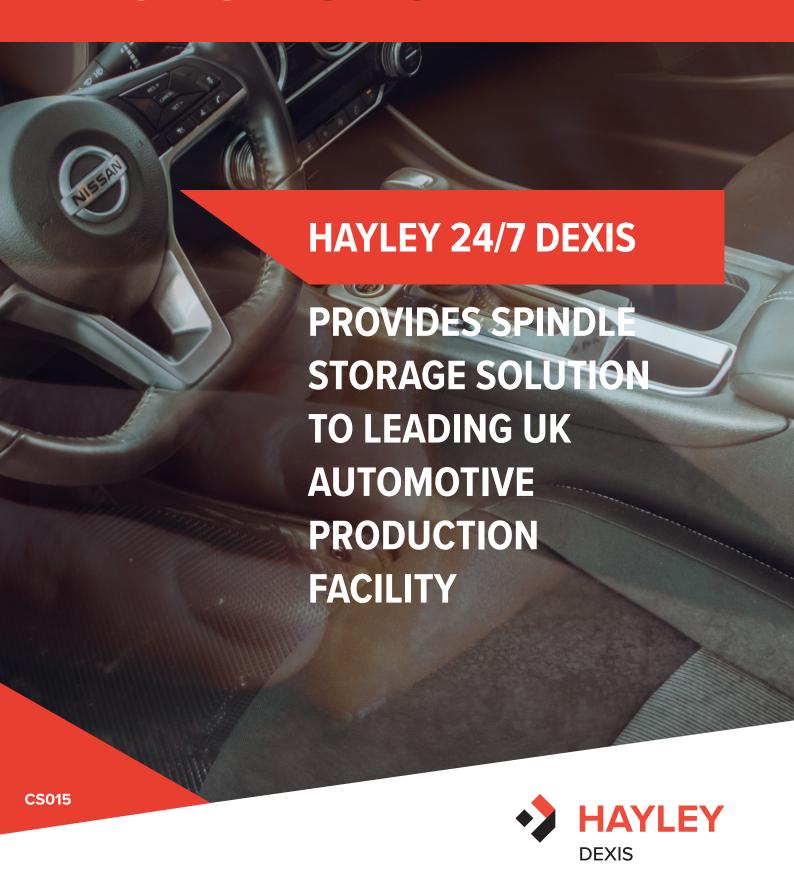
The team at HAYLEY 24/7 DEXIS designed two bespoke frames, able to hold 15 spindles each. Once the design had been accepted, the frames were manufactured from mild steel materials, cut and welded under coded conditions, and plastic-coated to the clients' specifications. Also, carriers were designed and manufactured by the team, to suspend the spindles from the frame runners.

Stored spindles used in the body shop are now easily accessible to staff and can be loaded/unloaded from either side.
